Story Spring Creek Stream Restoration & Fish Habitat Enhancement

Location: Belgrade, Montana

Client: Private Landowner

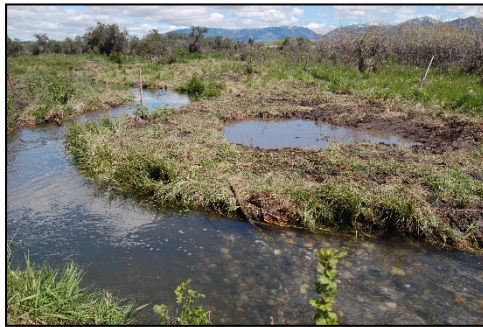
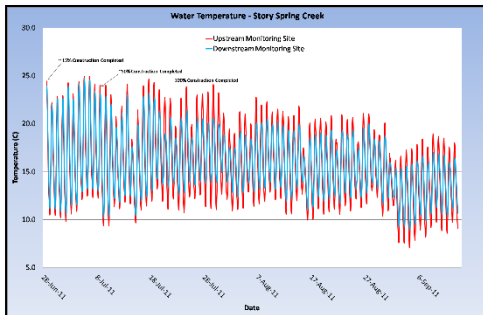
RE, LLC's principals developed a design to restore over 9,800 feet of the degraded channel. A process based design approach was used to develop and execute a plan that restored channel function and aquatic habitat, and re-established willows and riparian vegetation throughout the reach. To attain the appropriate channel geometry, a 'bank

translation' technique was used to narrow the channel cross section, separating the active channel from adjacent shallow emergent wetlands. New channel banks were constructed with wetland sod harvested from the existing stream corridor.

The restoration project resulted in a naturally functioning channel that is significantly narrower and deeper, has an improved thermal regime, and the quantity and quality of aquatic habitat has substantially increased. Enhanced hydraulic efficiency has scoured pools and washed fines from the stream bed; gravels have been mobilized and sorted, and trout have been observed spawning in the project reach. The restored willow community and riparian vegetation have stabilized stream banks, provided overhead trout cover, and combined with the narrower channel geometry, has greatly reduced solar input and atmospheric warming, thus reducing overall water temperatures and diurnal extremes, providing ideal conditions for trout growth and survival.
